**After Action Report: October 4, 2017 and October 12, 2017
Site Visits
Table Top Site Investigation
27th Avenue Remediation Site,
Maricopa County, AZ**

December 1, 2017

**Prepared by:
UXO Pro, Inc.
15 Park Avenue
Gaithersburg, MD. 20877**

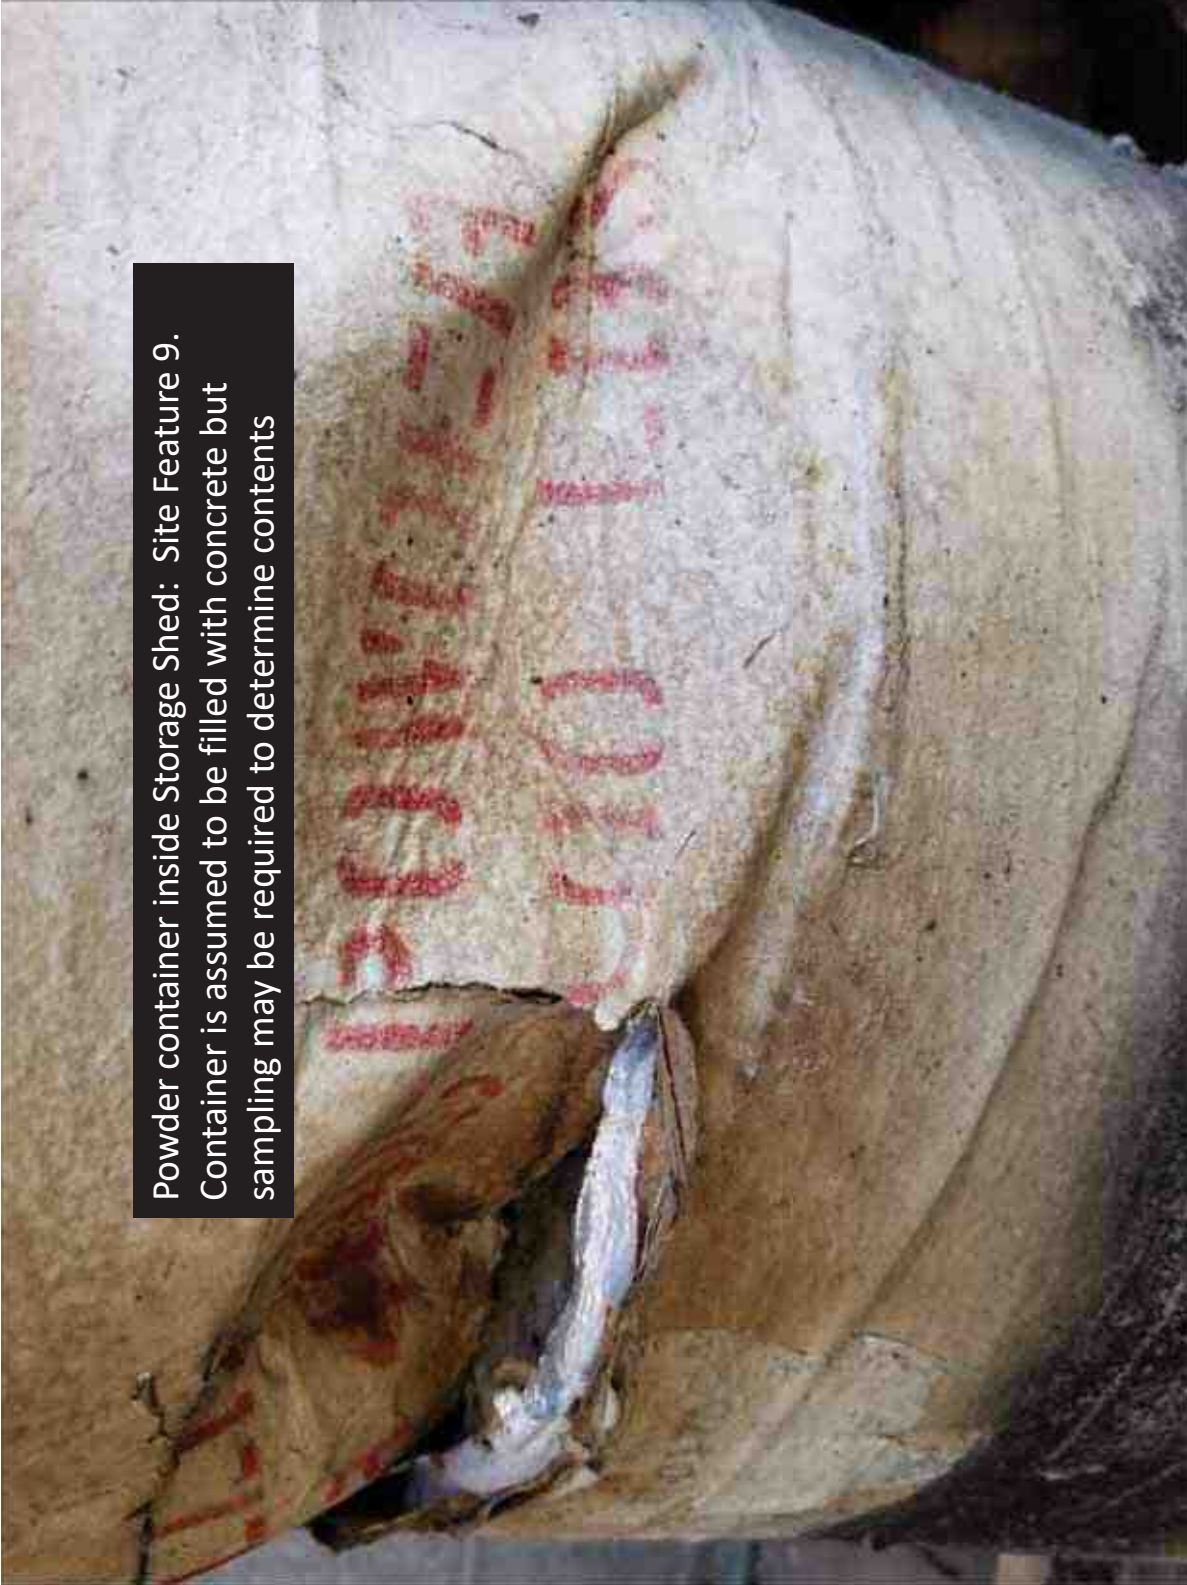
Powder container inside Storage Shed: Site Feature 9.
Container is assumed to be filled with concrete but
sampling may be required to determine contents

- Recommendations
 - The contents of the “Pull Down Powder” container is assumed to be concrete but testing is recommended of the material for verification purposes.
 - An armored-up excavator is recommended to demolish the building and safely remove the building contents. The contents can then be distributed on the grounds outside of the building and sorted through to allow UXO Technicians to inspect the material and certify that any potential explosive hazard have been properly removed.
 - The UXO Companies competing for the work should be required to present alternatives to building demolition as part of their technical approach.

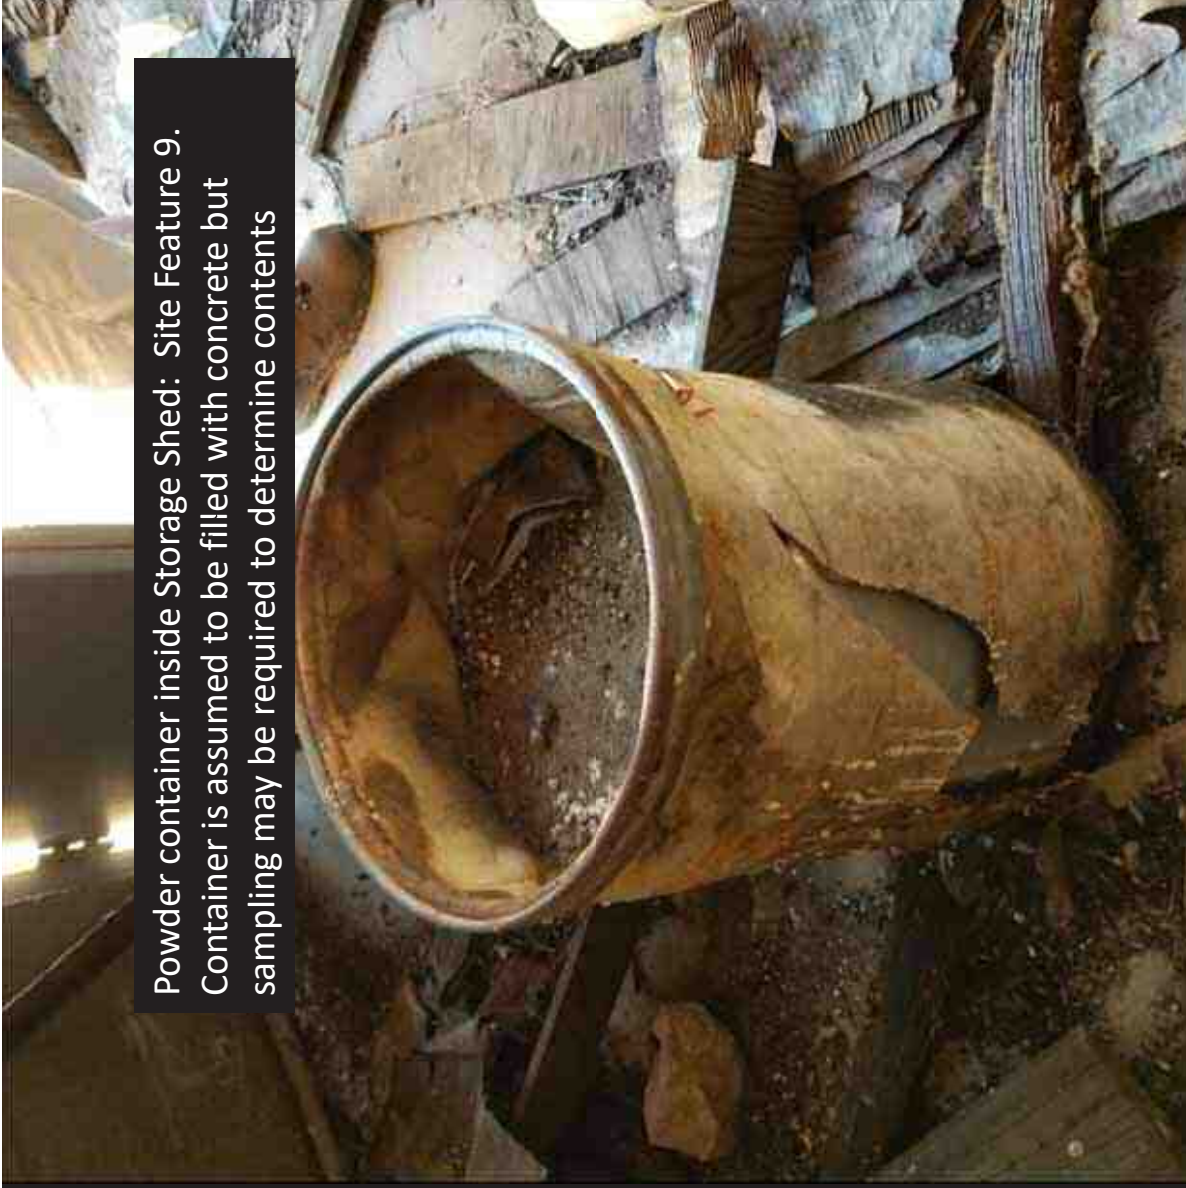
Powder container inside Storage Shed: Site Feature 9.
Container is assumed to be filled with concrete but
sampling may be required to determine contents

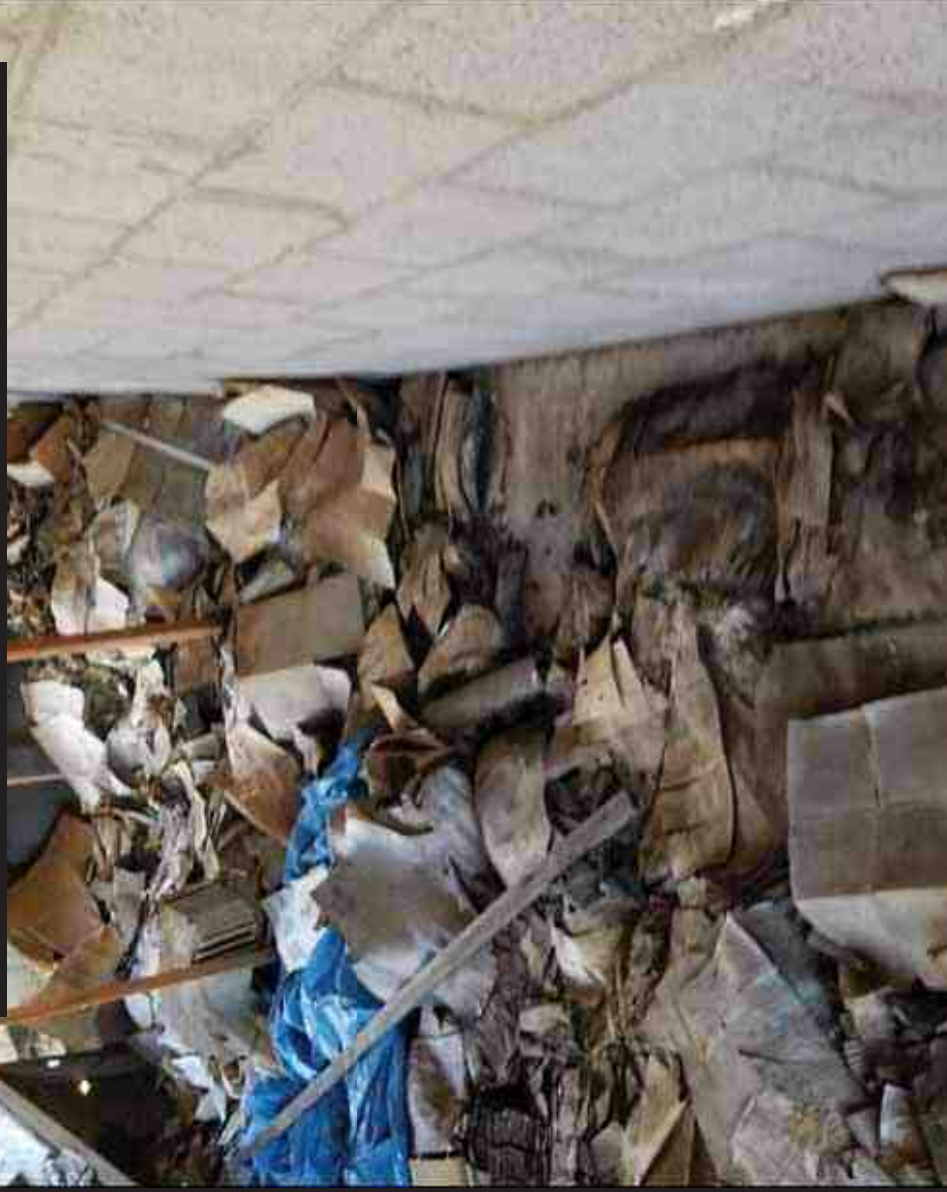
The storage shed is a concrete block wall structure. The walls are intact, but the roof has been compromised. The interior contains folded cardboard boxes and debris ranging from a couple feet to approximately four feet deep of materials. Cardboard casings were observed throughout the storage shed that appear to be containers for the “flash bang” grenades. A few accessible casings were inspected and observed empty. There wasn't any indications of explosives or residue inside the casings. In addition, a metal/ceramic (material unknown) container which appeared to be a type of fabricated grenade body was also observed in the shed but its designed purpose has not been confirmed. A drum labeled “Pull Down Powder” was also present in the storage shed. The building does not appear to be constructed of, or contain any, asbestos material. Outside of the building is a small armored bunker that has been constructed on skids. The bunker appears to have been used to protect personnel from fragmentation from detonations. Cultural debris is littered around the site and should be removed prior to the geophysical investigation. Immediately to the west of the storage shed and bunker is a large wash in which historical documents indicate fragmentation grenades were discovered. The Site Visit Team performed visual instrument aided meandering transects around the structure, in the wash, and on the sides of the wash to identify the presence of surface and subsurface anomalies. No MEC or IEDs were identified at this location. However, MD items were discovered. Grenade spoons and fuzes were discovered at various locations inside the wash.

Storage Shed: Site Feature 9. Building is recommended for removal

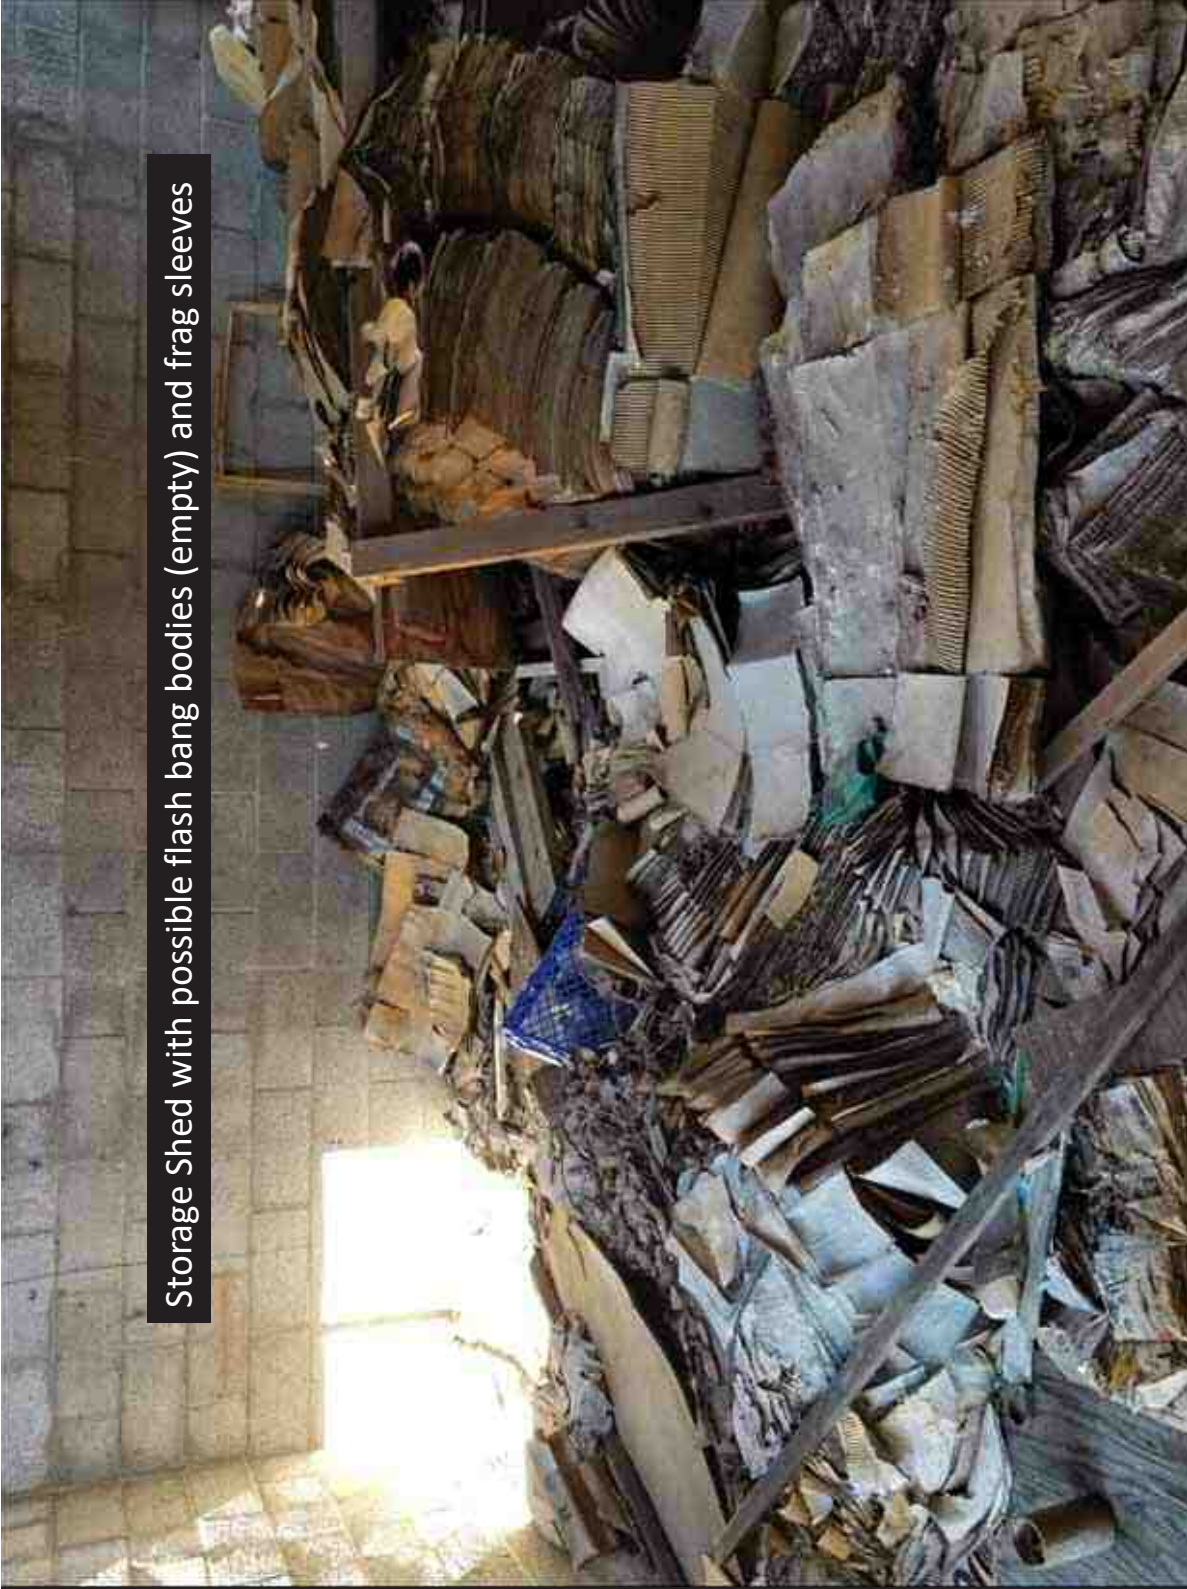
Storage Shed with possible flash bang bodies (empty) and frag sleeves

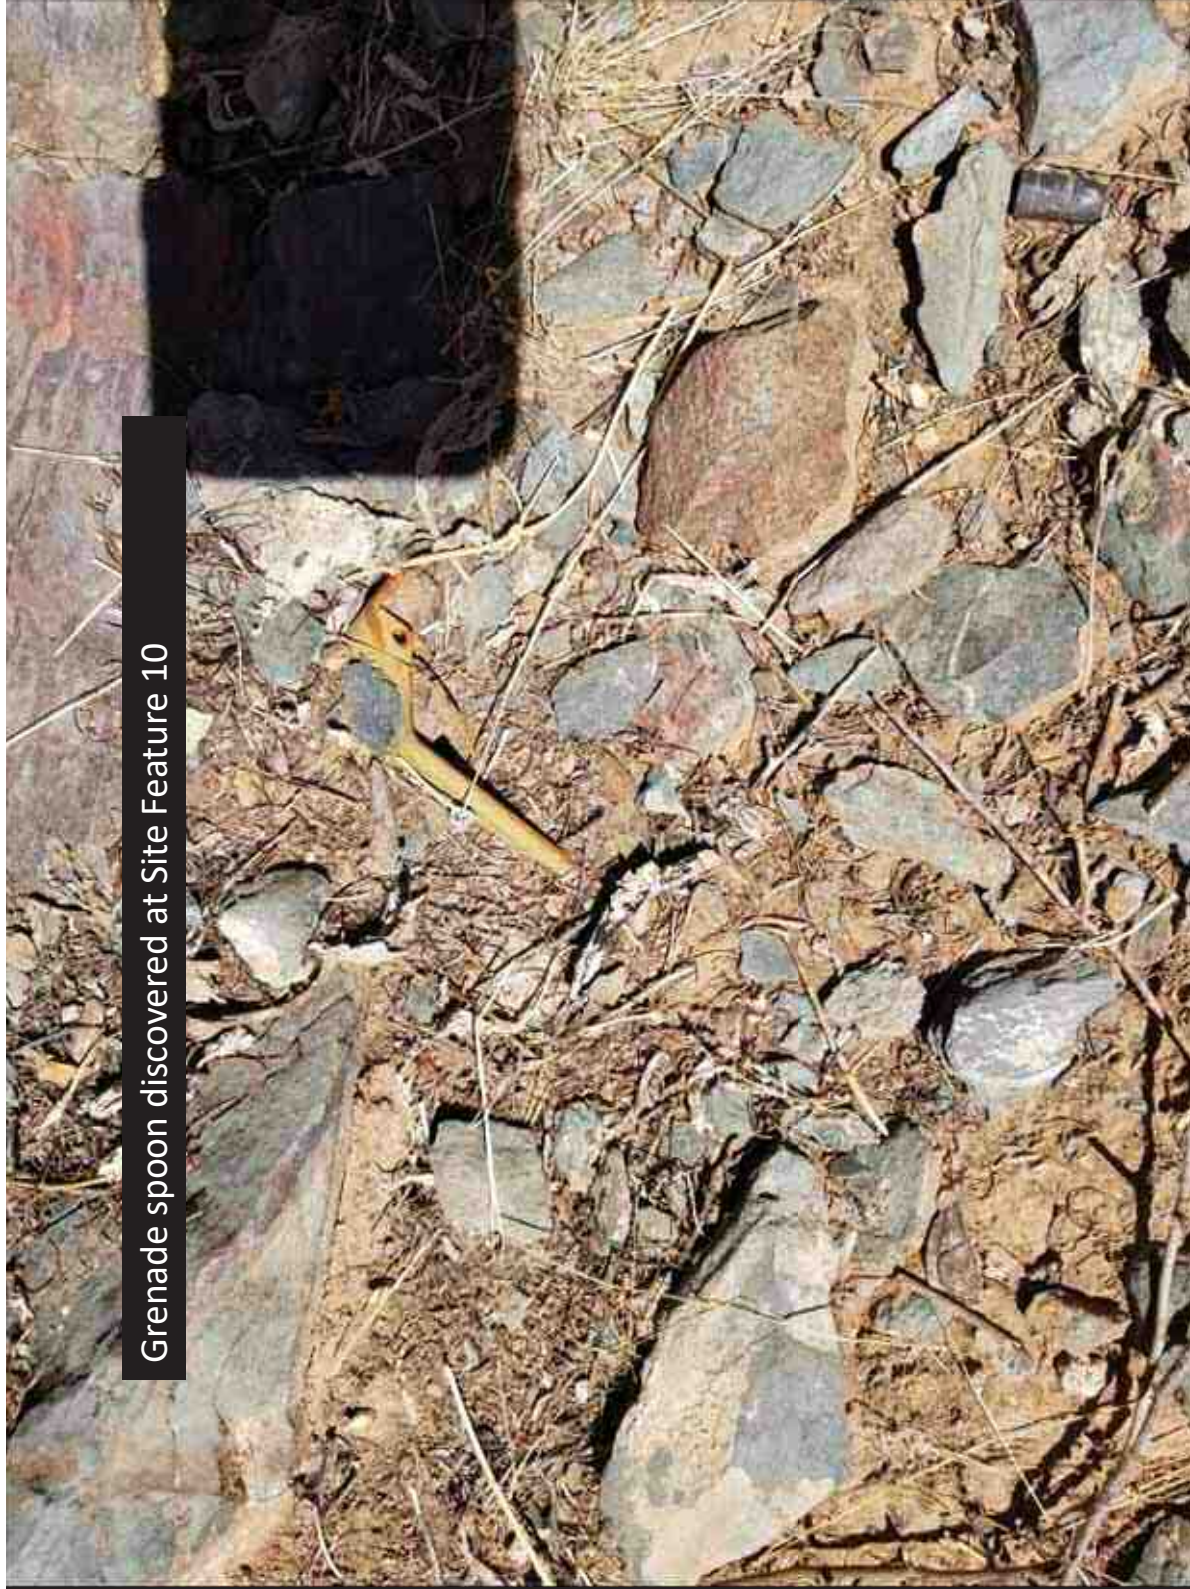
Grenade spoon discovered at Site Feature 10

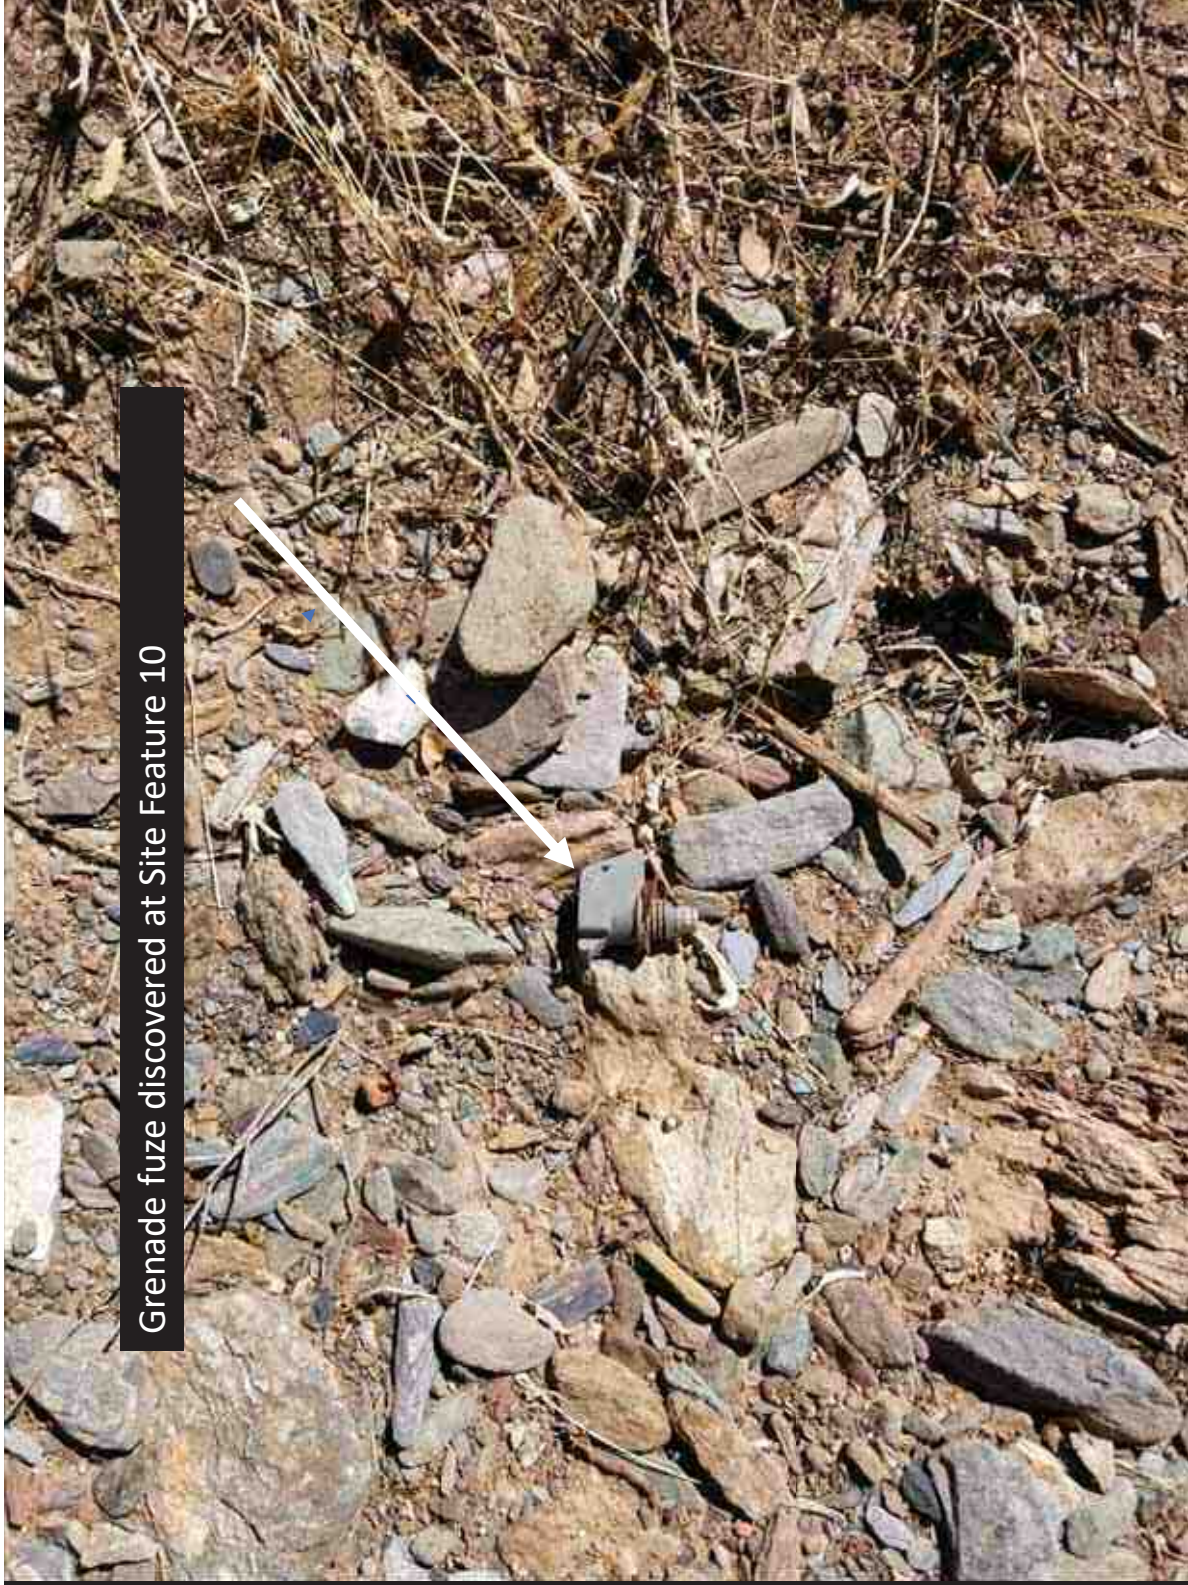
Grenade fuze discovered at Site Feature 10

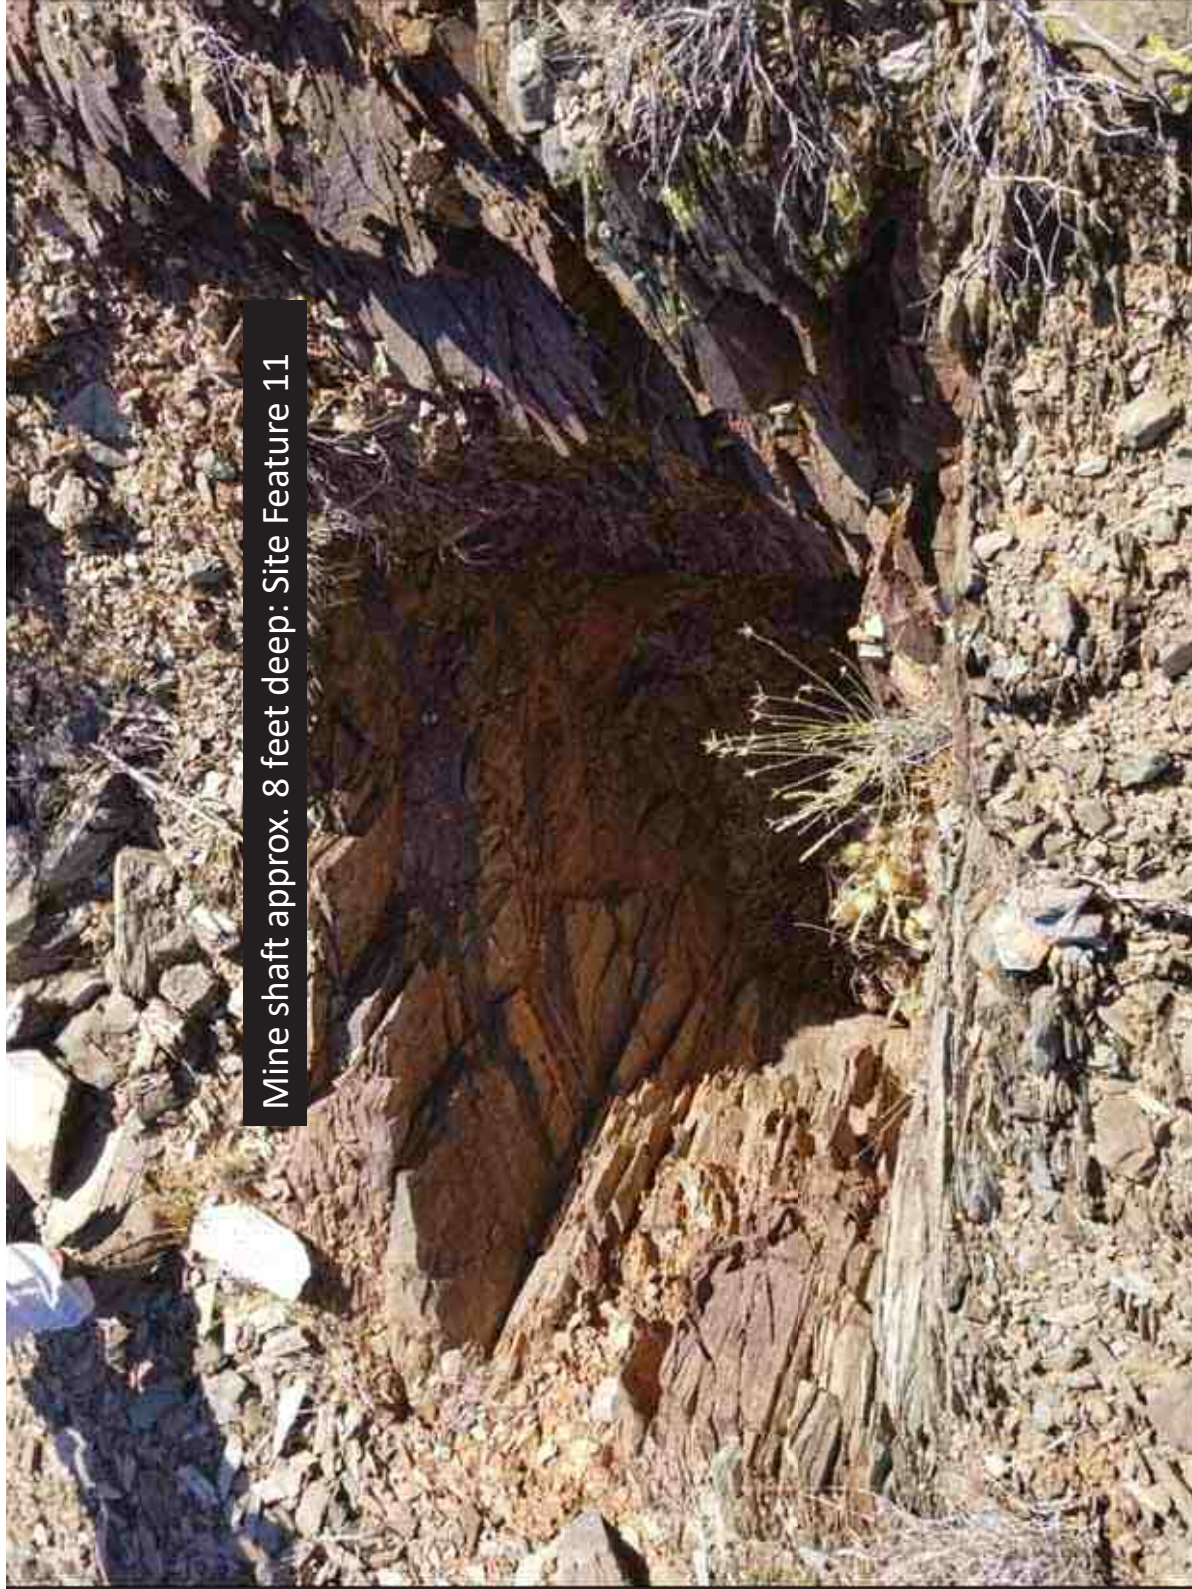
Mine shaft approx. 8 feet deep: Site Feature 11

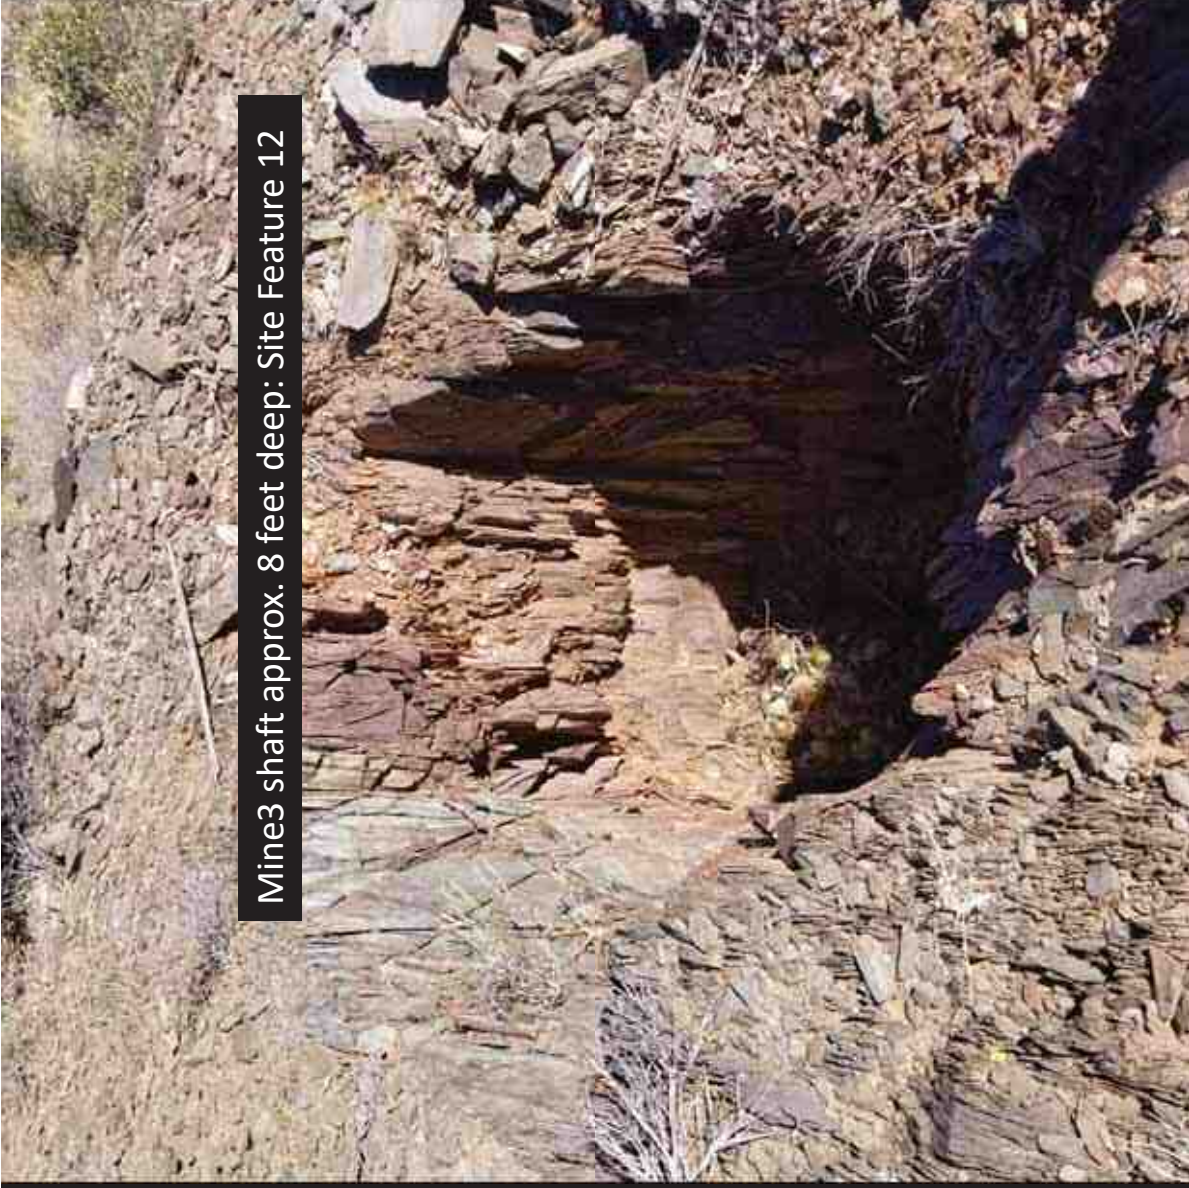
Mine3 shaft approx. 8 feet deep: Site Feature 12

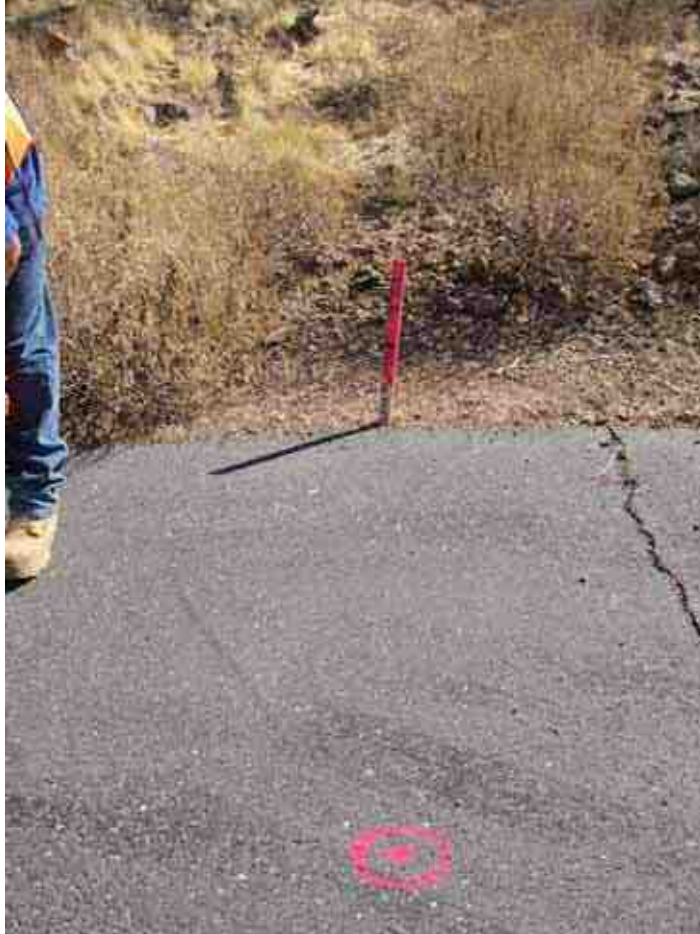
Photo 3—Survey point in the middle of the neighboring property's driveway. Note, the points are supposed to be 10' *inside* the property line.

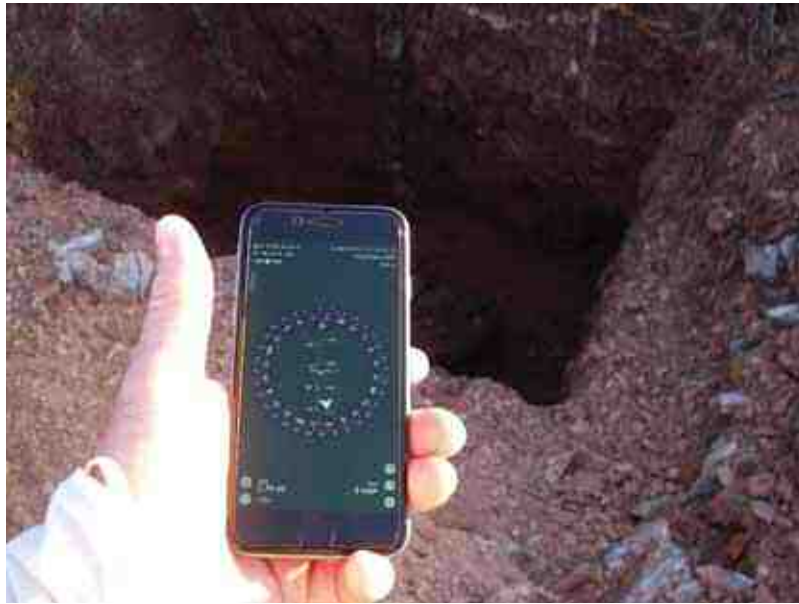
Photo 5—Mine discovered on 10/6/17

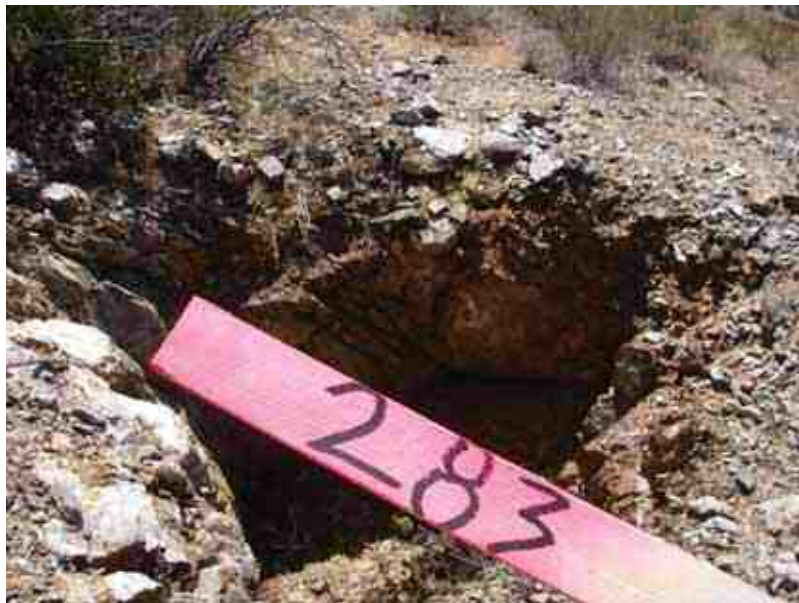
Photo 6—Second mine discovered on 10/6/17

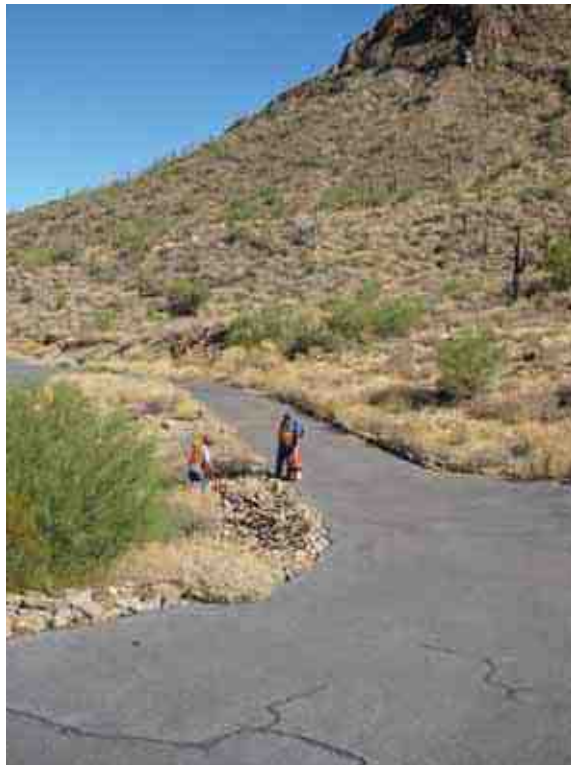
Photo 10—Stake to left of the driveway. The point indicated by the stake is approximately 10' to the left (west) of the property line. All of the driveway adjacent to the surveyed point is on to the 27th Avenue Remediation Site property. Photograph is taken looking North.
